**SECOND FIVE-YEAR REVIEW REPORT
ROCKAWAY TOWNSHIP WELLS SUPERFUND SITE
ROCKAWAY TOWNSHIP, MORRIS COUNTY, NEW JERSEY**

September 2015

**U.S. Environmental Protection Agency
Region 2
New York, New York**

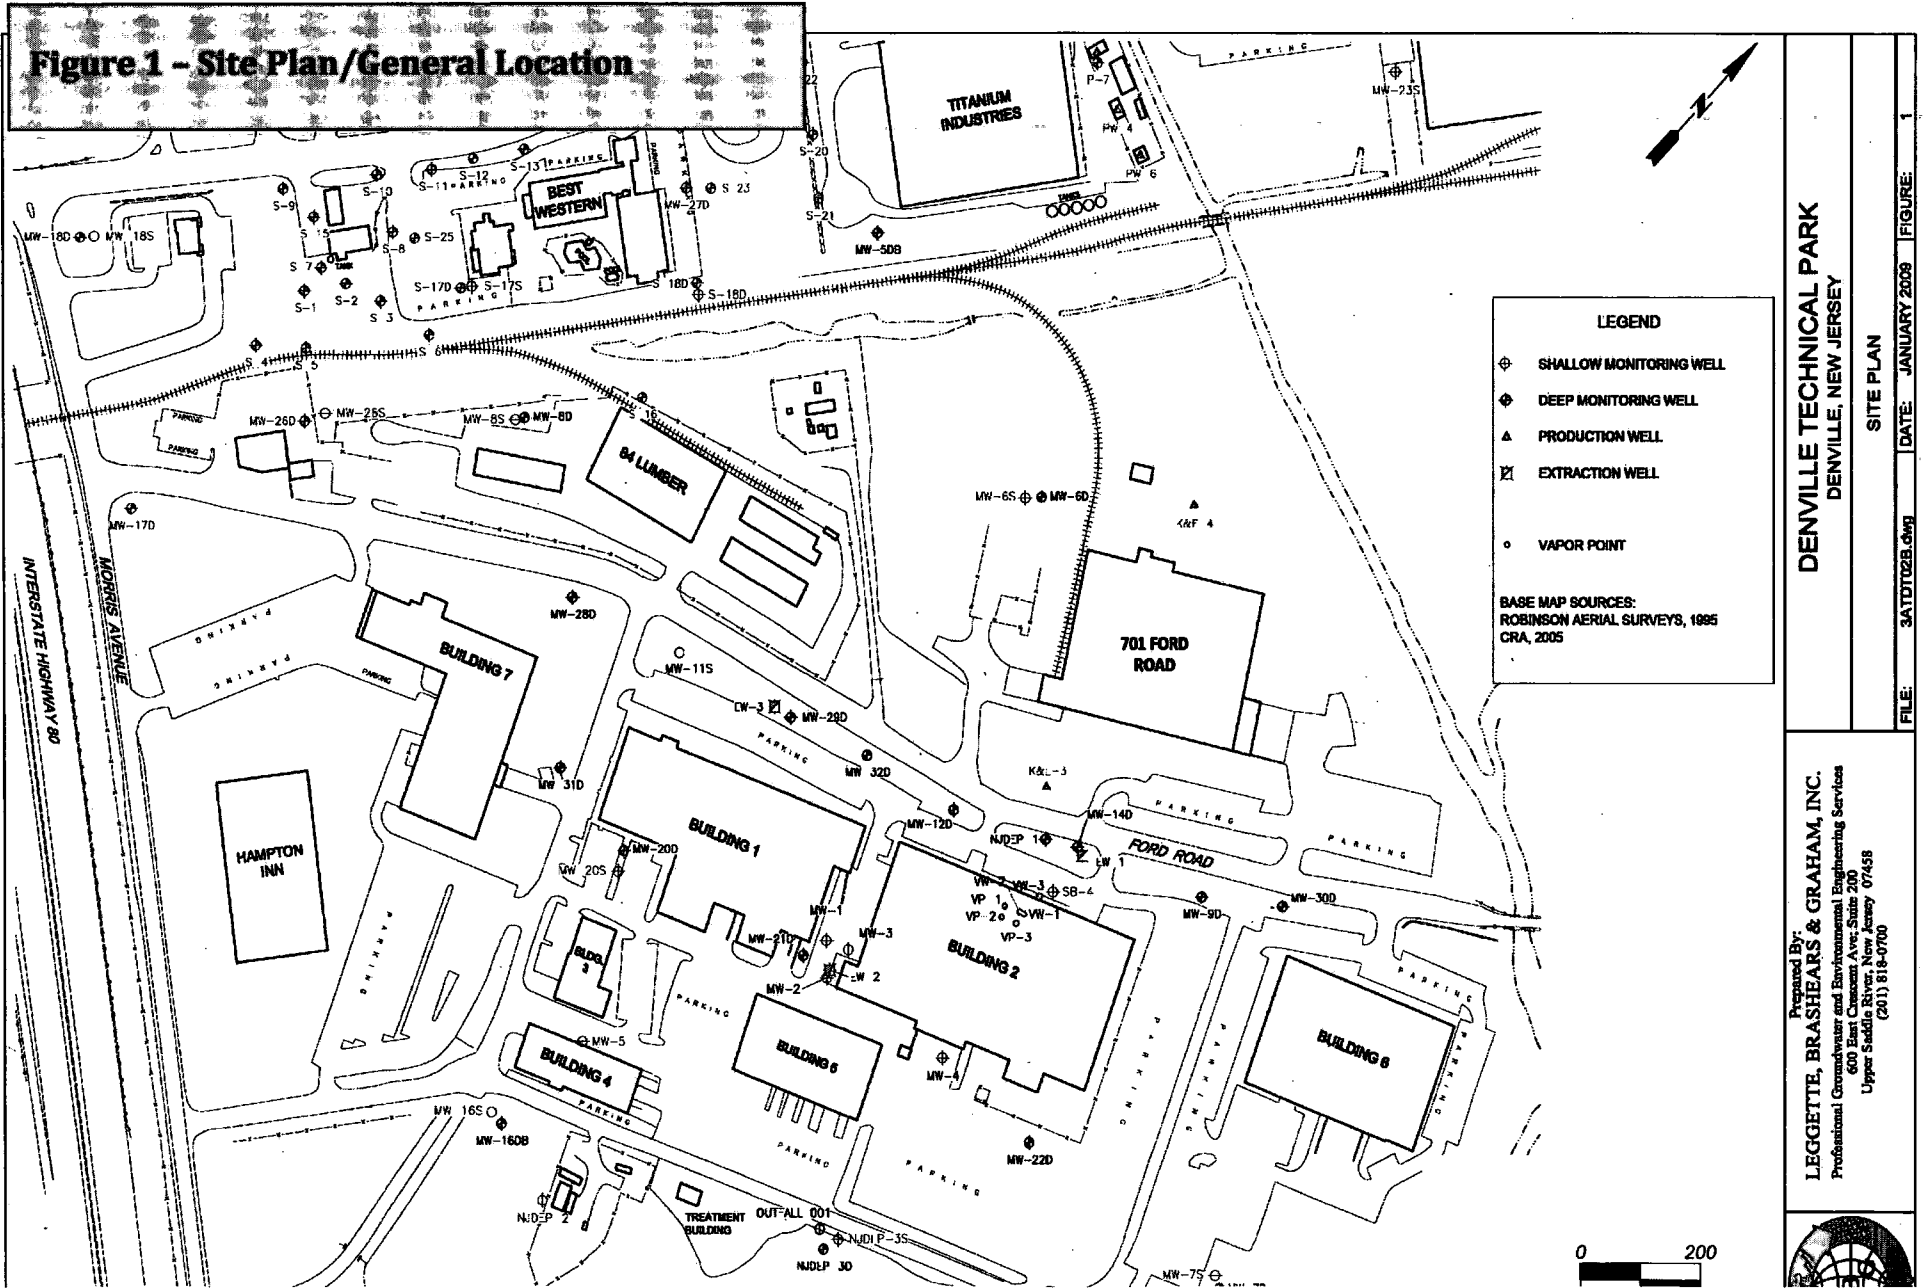
Figure 1 - Site Plan/General Location

RTW is located in Rockaway and Denville Townships, Morris County, New Jersey. Figure 1 (Source: 2014 Remedial Action Progress Report Denville Technical Park prepared by Leggette, Brashears & Graham for Alliant Techsystems, Inc., January 2015) provides a site plan with general location information. This FYR was conducted by the United States Environmental Protection Agency (EPA) Remedial Project Managers (Ronald Naman and Lawrence Granite) with support from EPA colleagues, pursuant to Section 121 (c) of the Comprehensive Environmental Response, Compensation, and Liability Act (CERCLA), as amended, 42 U.S.C. §9601 *et seq.* and 40 CFR 300.430(f)(4)(ii), and in accordance with the *Comprehensive Five-Year Review Guidance*, OSWER Directive 9355.7-03B-P (June 2001). This report will become part of the Site file.

The Site, as defined by the areal extent of the contaminated groundwater plume, lies in the center of a Y-shaped valley in an otherwise hilly area of the New Jersey Highlands on approximately 183 acres located immediately north of Interstate 80 (Figure 1). The general area is predominantly non-residential industrial-zoned land which includes the Denville Technical Park (DTP) (an industrial building complex). Area development includes commercial businesses, light industries including service stations, restaurants, hotels, plastic manufacturers, truck/transit companies, and commercial office complexes. The 2010 census population for Rockaway Township was recorded as 24,156. The source area of Site-related contamination is predominantly located in Denville Township, while the impacted downgradient water supply wells are located in Rockaway Township. The site overlies, and the municipal wells draw water from, the Buried Valley Aquifer Complex (Upper Rockaway subsection) which is considered a sole source aquifer system. Beaver Brook (the closest surface water body) lies to the east and northeast of the site.

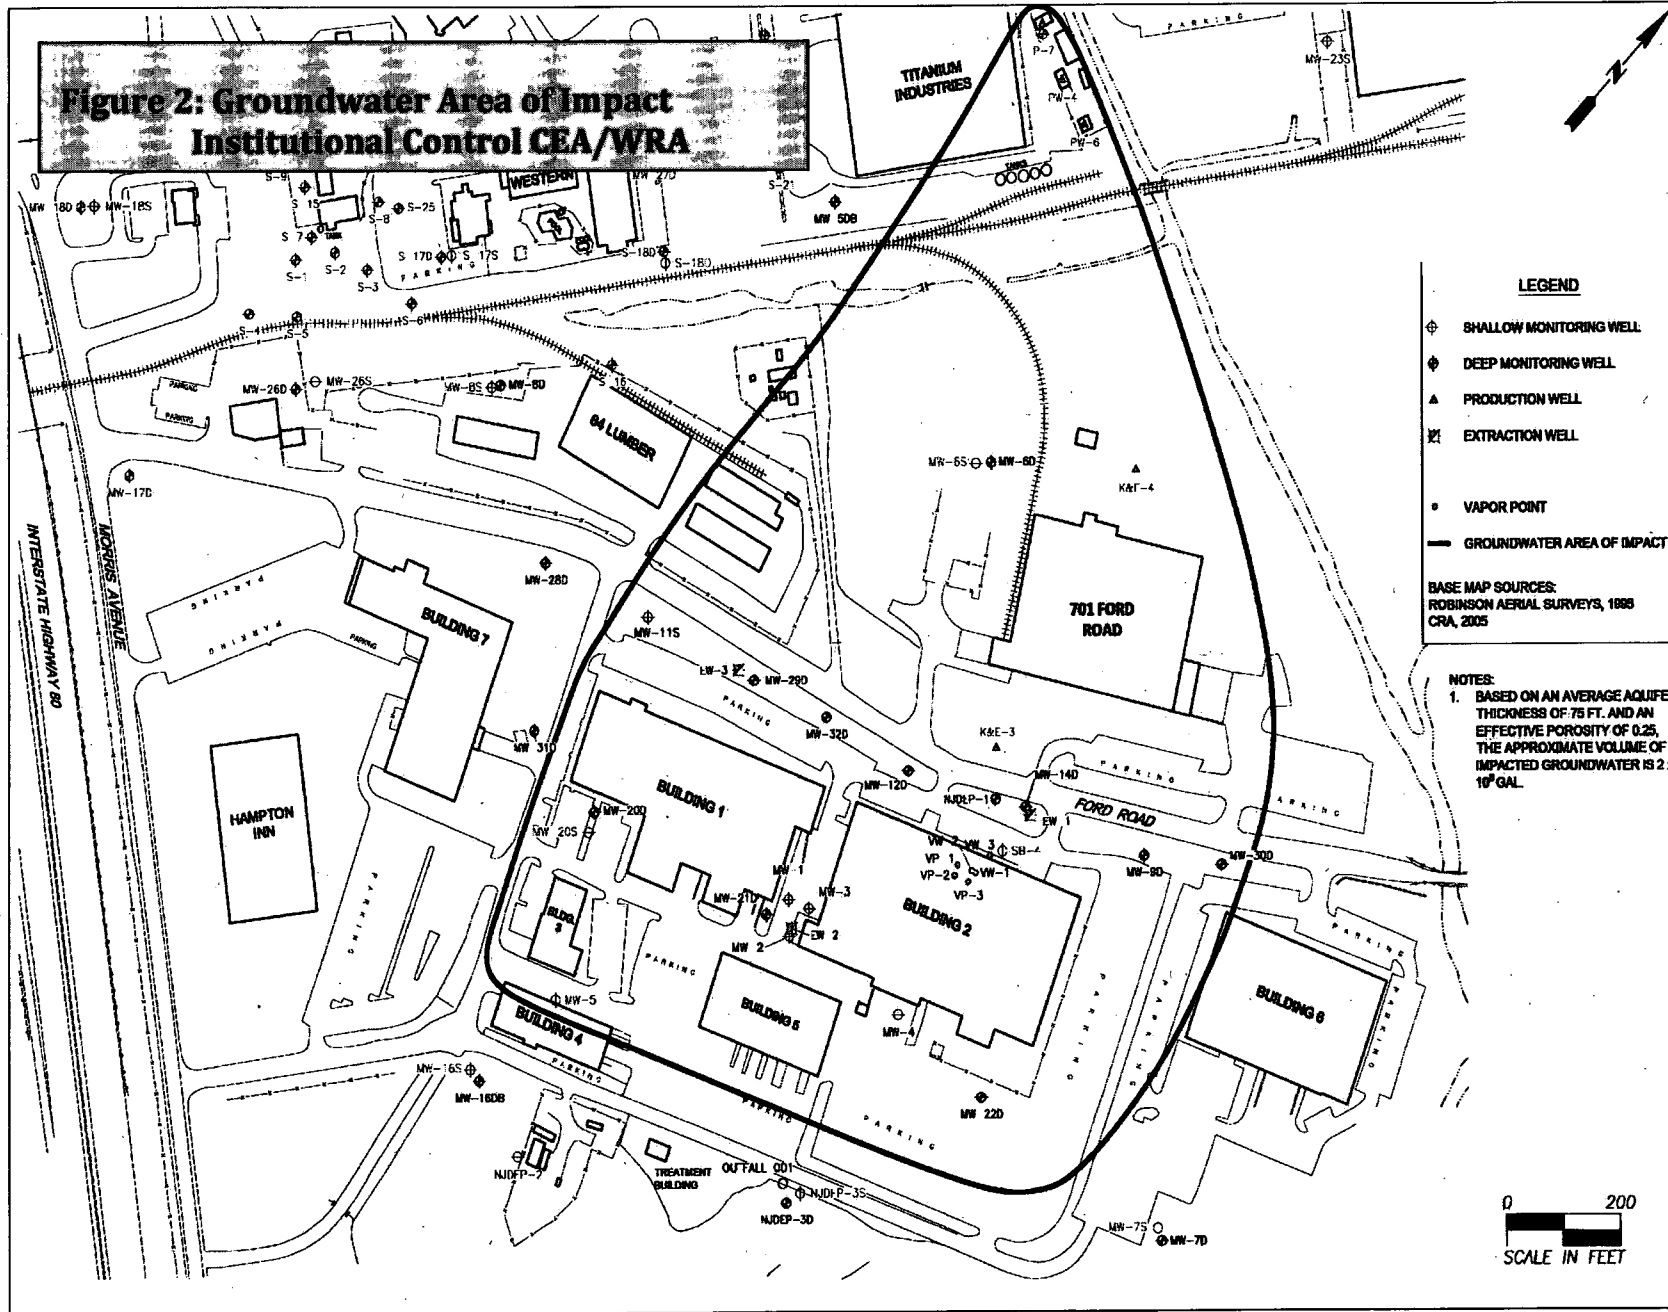
**Figure 2: Groundwater Area of Impact
Institutional Control CEA/WRA**

A Classification Exception Area/Well Restriction Area (CEA/WRA) (Site CEA ID# NJD980654214/Case ID# G000004876) was issued for the Site by the NJDEP on November 17, 2000. Figure 2 provides a site base map with the groundwater area of impact (approximate areal boundary of the CEA/WRA) delineation. The CEA/WRA was established to provide notice that the constituent (groundwater) standards for the aquifer are not or will not be met in the localized groundwater plume area, and that the designated aquifer use (Class II-A/waters designated for potable drinking water use) are suspended in the affected area for the term of the CEA/WRA. The RTW CEA/WRA is listed (NJDEP Open Public Records Database) as active and includes mapped well restriction boundaries equivalent to the locally contaminated area of the Buried Valley/Upper Rockaway Sole Source Aquifer. The initial term of the CEA/WRA is listed as ten

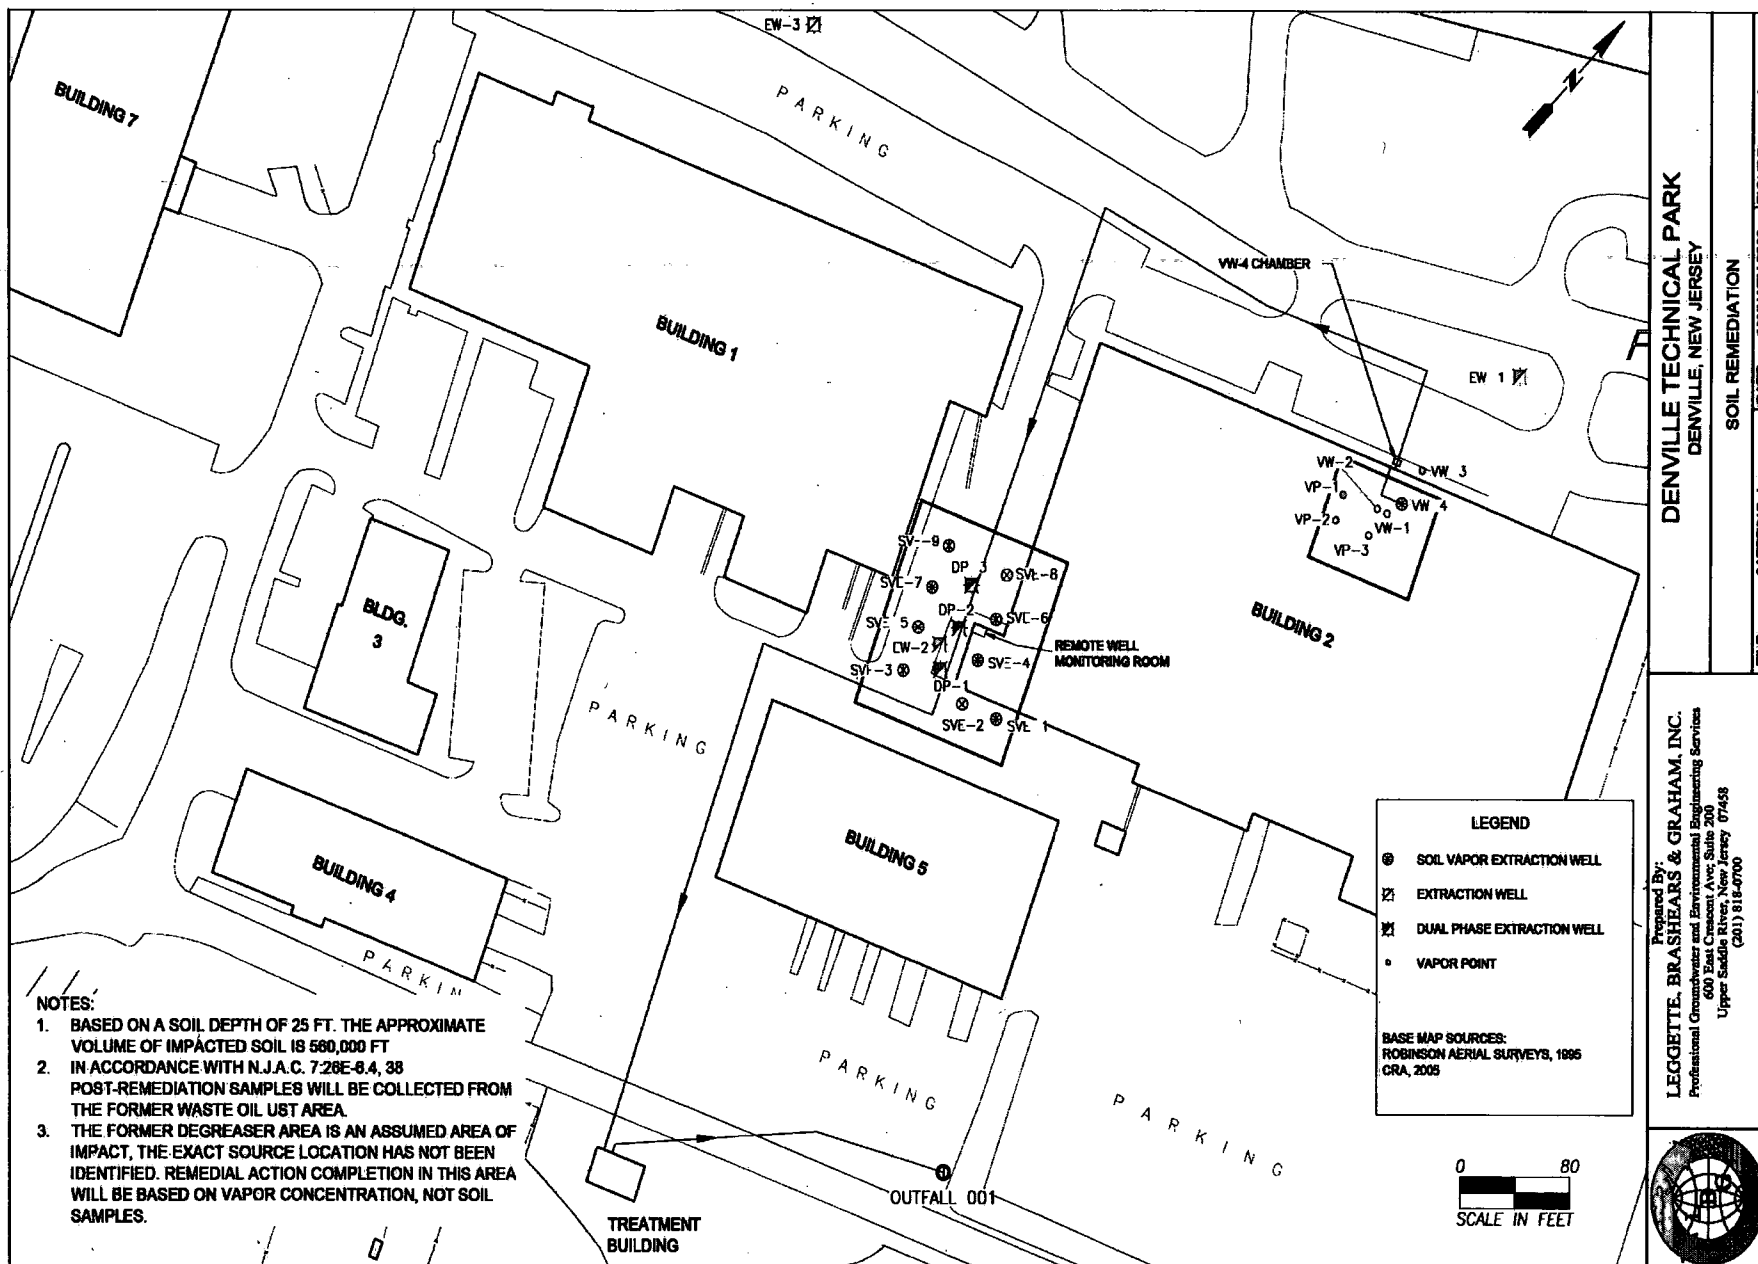
Figure 5: DP and SVE Well Locations

The SVE remediation system was installed in June 2005. The SVE system consists of 10 extraction wells used in conjunction with the three DP wells. Nine of the SVE wells are located between Buildings 1 and 2 in the vicinity of the former UST area. The remaining SVE well is located beneath Building 2 in the vicinity of the Former Degreaser Area. Figure 5 shows the location of the SVE wells. Extracted vapors are routed to vapor-phase carbon for treatment prior to discharge in accordance with air permits issued through the State of New Jersey. Air samples collected from the carbon treatment system effluent show that air permit discharge requirements for the system are being met.
